ADVANCE REPORT  
on the  
SEDIMENTATION INVESTIGATIONS  
of  
RESERVOIRS AND NAVIGATION IMPROVEMENTS  
on the  
NEW RIVER, VIRGINIA AND WEST VIRGINIA

April 14 - May 22, 1936

Carl B. Brown and Farrell F. Barnes

Division of Research  
Section of Hydrodynamic Studies  
SCS-SS-6  
August, 1936

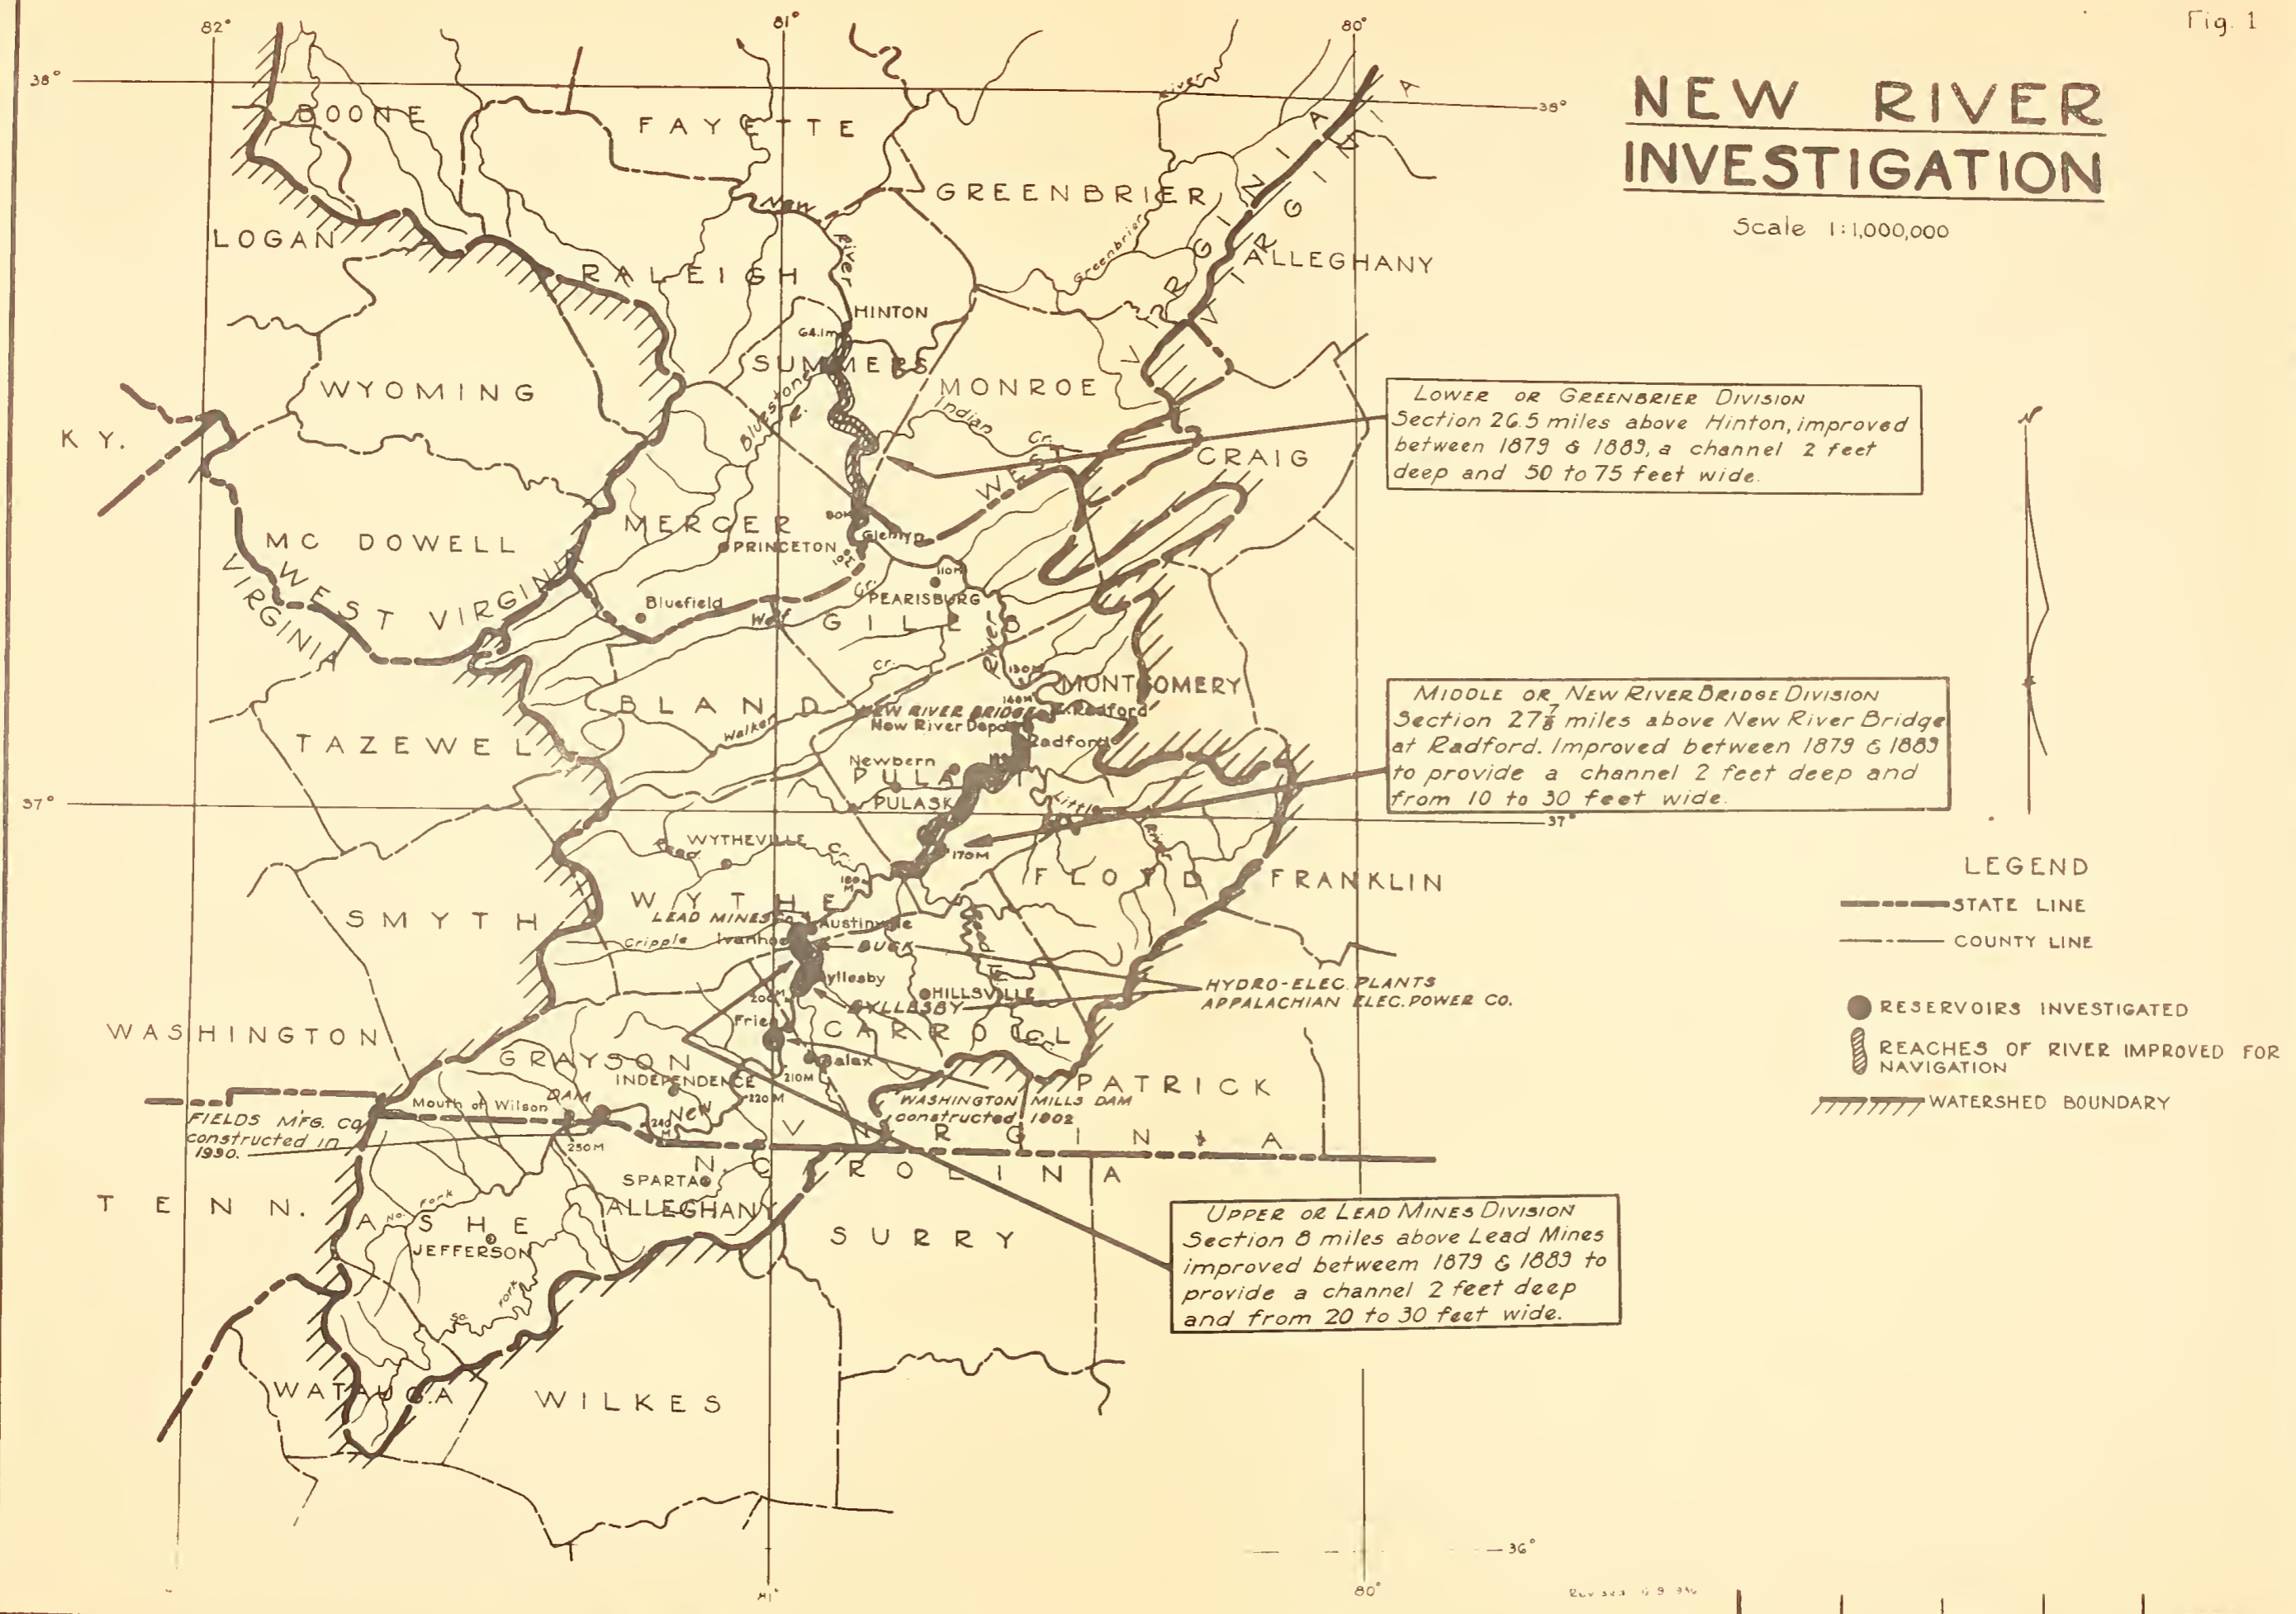
Fig. 1

The locations of the reservoirs and navigation improvements are shown in Figure 1.

LOWER OR GREENBRIER DIVISION  
Section 26.5 miles above Hinton, improved  
between 1879 & 1889, a channel 2 feet  
deep and 50 to 75 feet wide.

MIDDLE OR NEW RIVER BRIDGE DIVISION  
Section 27 $\frac{7}{8}$  miles above New River Bridge  
at Radford. Improved between 1879 & 1889  
to provide a channel 2 feet deep and  
from 10 to 30 feet wide.

UPPER OR LEAD MINES DIVISION  
Section 8 miles above Lead Mines  
improved between 1879 & 1889 to  
provide a channel 2 feet deep  
and from 20 to 30 feet wide.

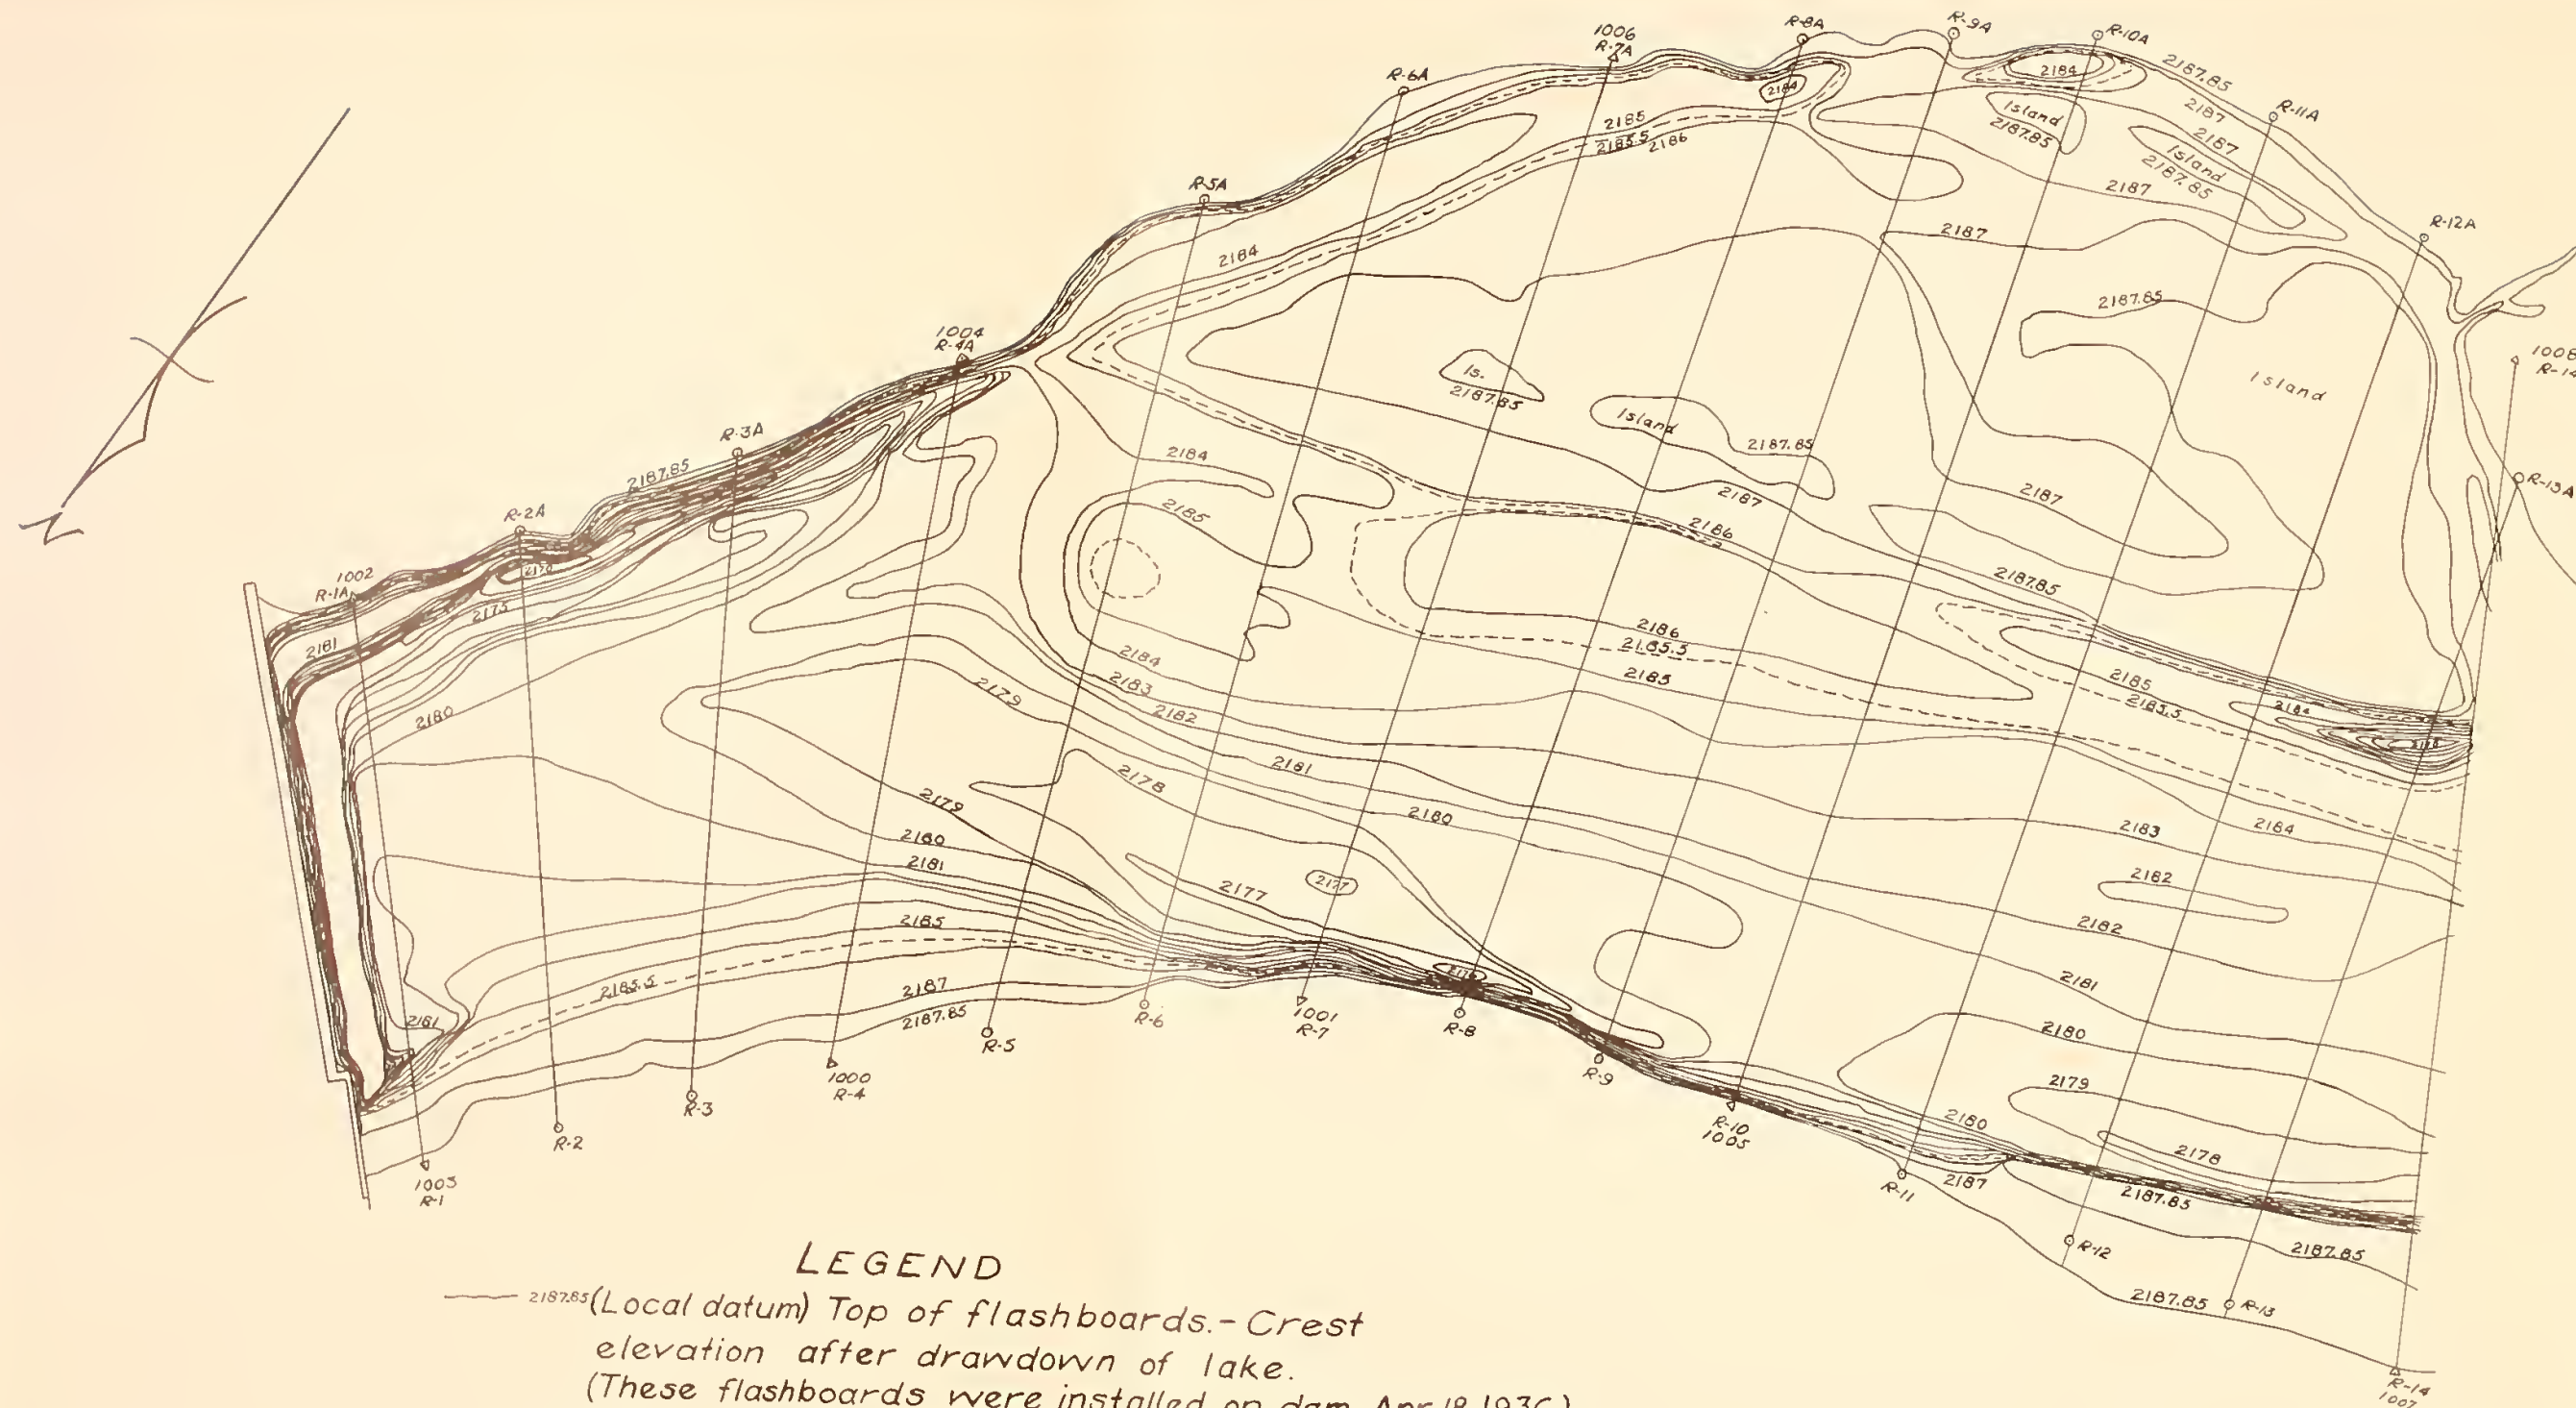
SHEET NO. 1

WASHINGTON MILLS RESERVOIR  
NEW RIVER  
FRIES, VIRGINIA  
STUDY OF EFFECTS OF DRAWDOWN

SOUNDINGS - APRIL 17, 1936

BEFORE DRAWDOWN

A special study of the effects of a single complete draw-down of the reservoir was also made. Soundings were taken in the lower 2,400 feet of the reservoir on April 17, 1936. On April 18, the five headgates, with bottoms 20 and 22 feet above the original stream bed at the dam, were opened from 7:00 a.m. to 4:00 p.m., allowing all the stored water and the normal discharge of the river to flow out. To determine the volume of sediment flushed out by this process, the part of the lake affected by the scouring, that is, the lower 2,400 feet, was resounded on April 23. Two contour maps were made from the two sets of soundings, taken before and after draw-down, and from these the volume of sediment evacuated from the reservoir was determined. ( figs. 2 and 3).

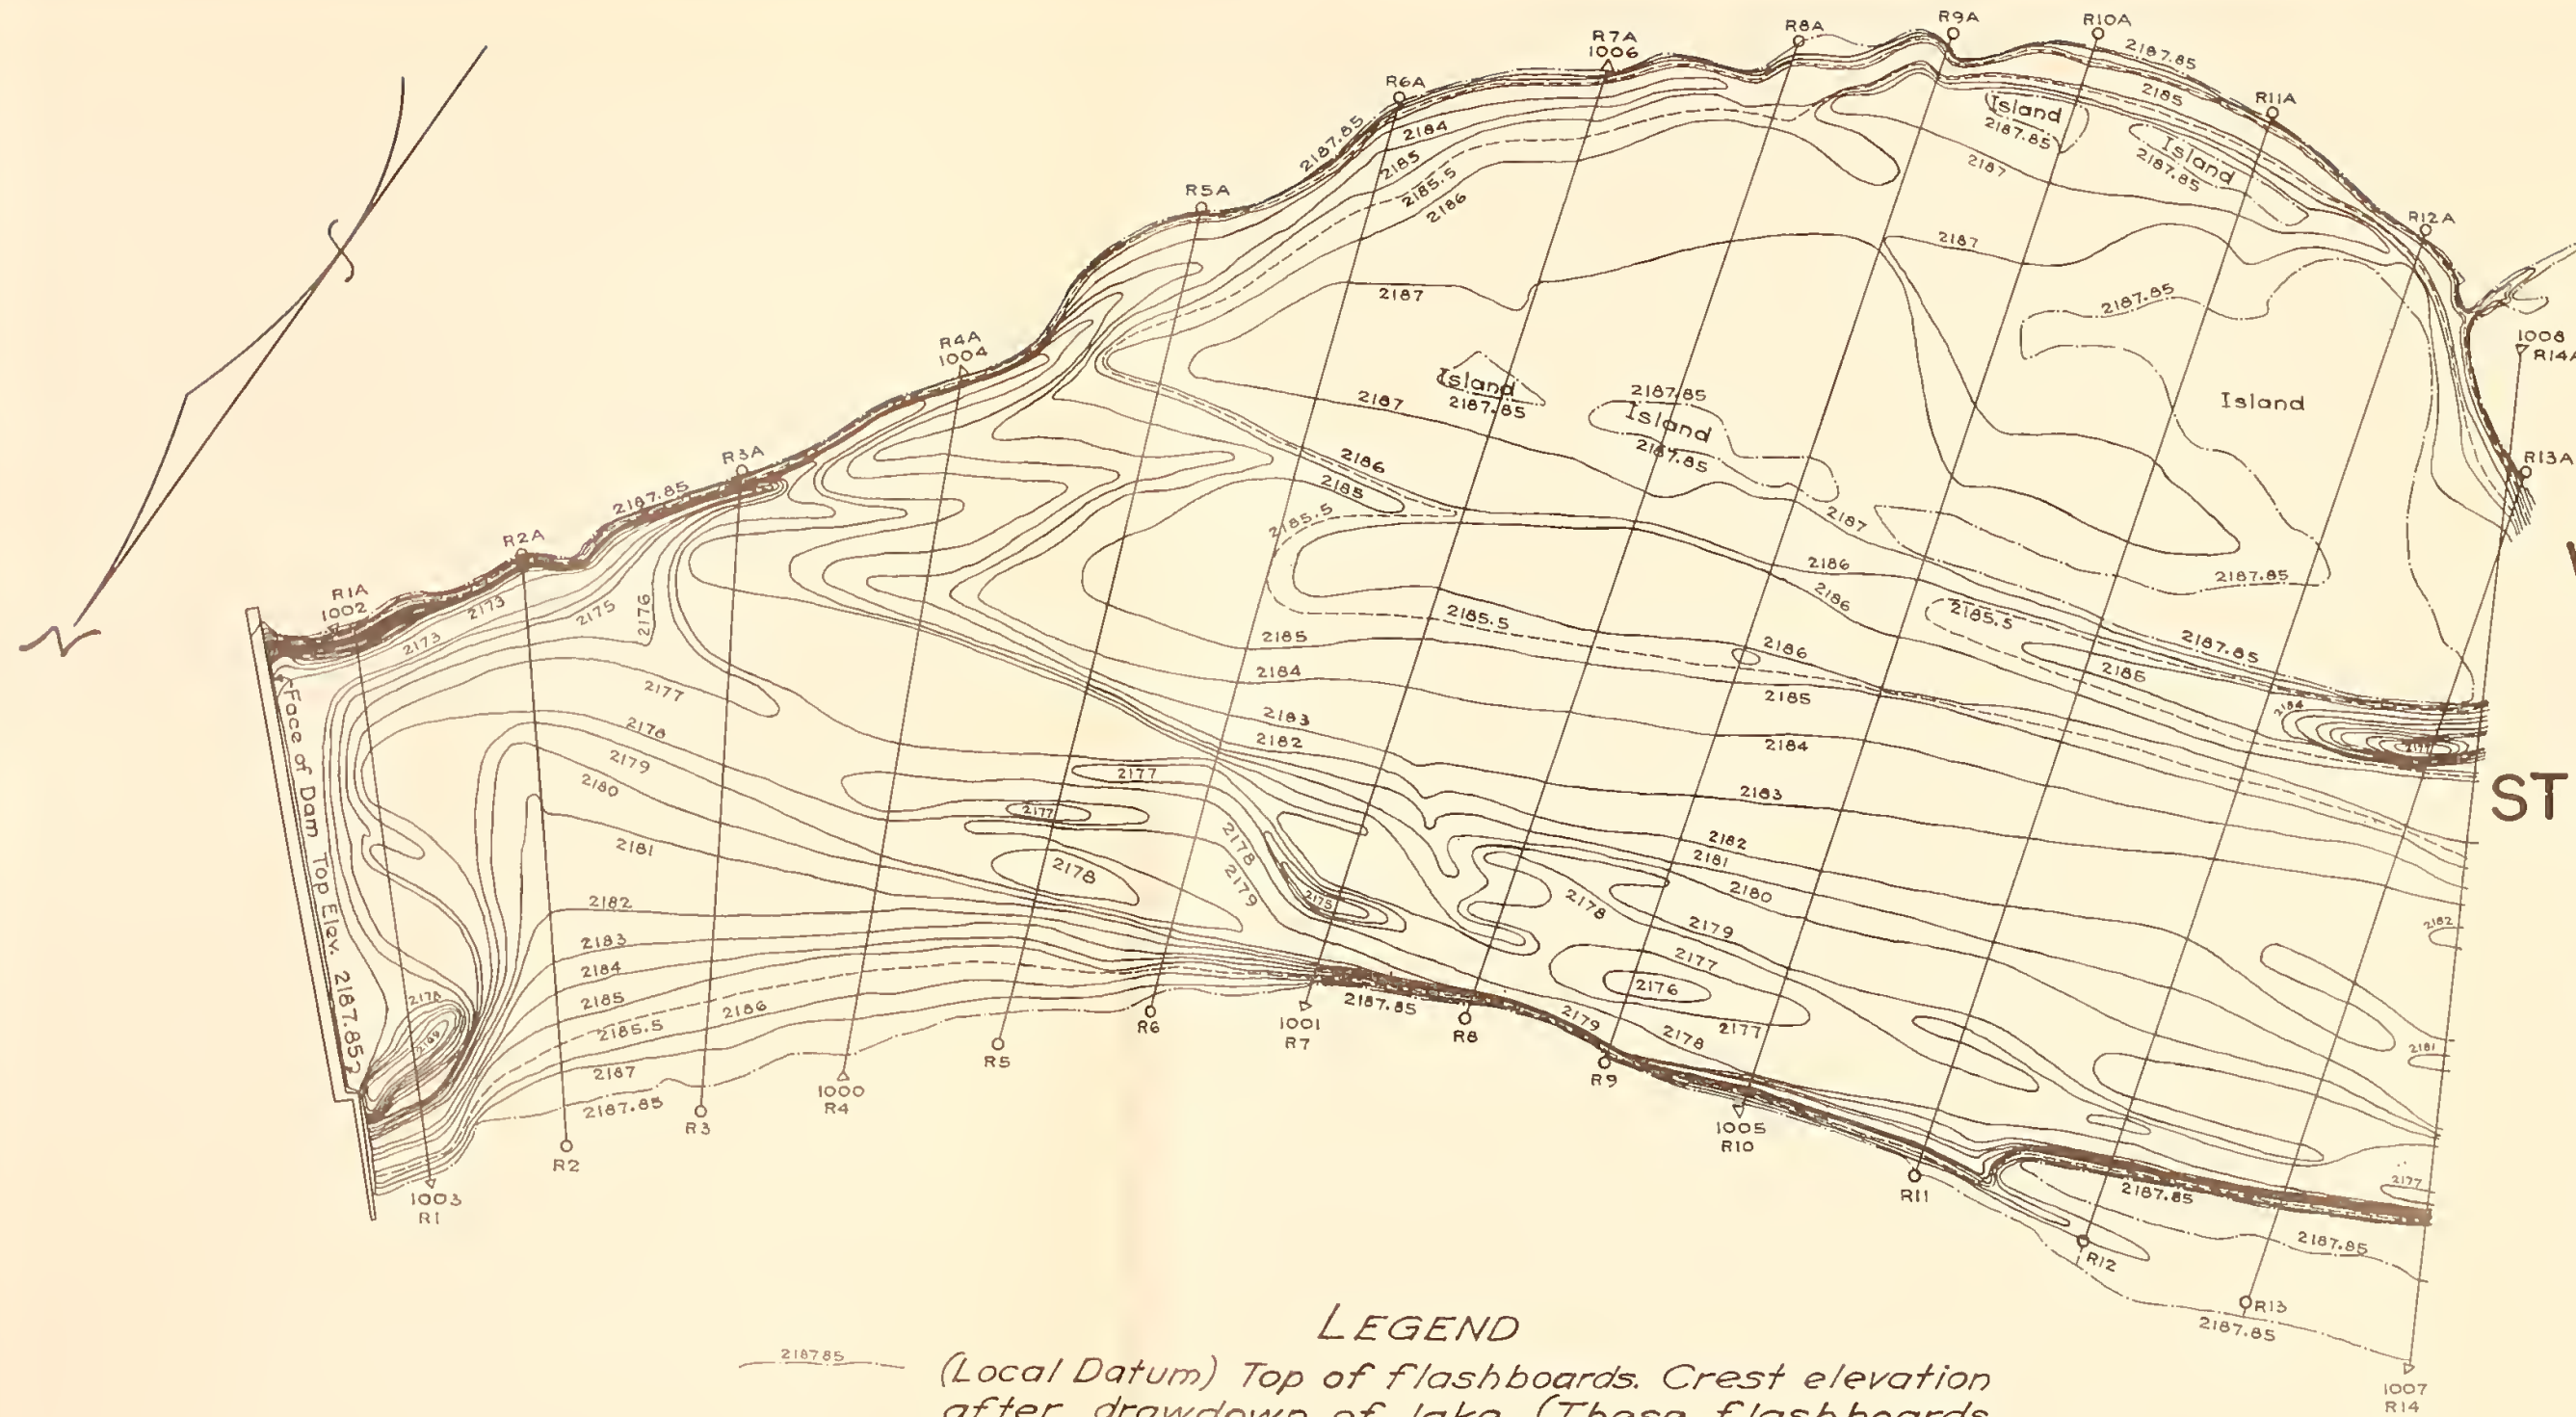
SHEET NO. 2

WASHINGTON MILLS RESERVOIR  
NEW RIVER  
FRIES, VIRGINIA  
STUDY OF EFFECTS OF DRAWDOWN

SOUNDINGS APRIL 23, 1936 — AFTER DRAWDOWN

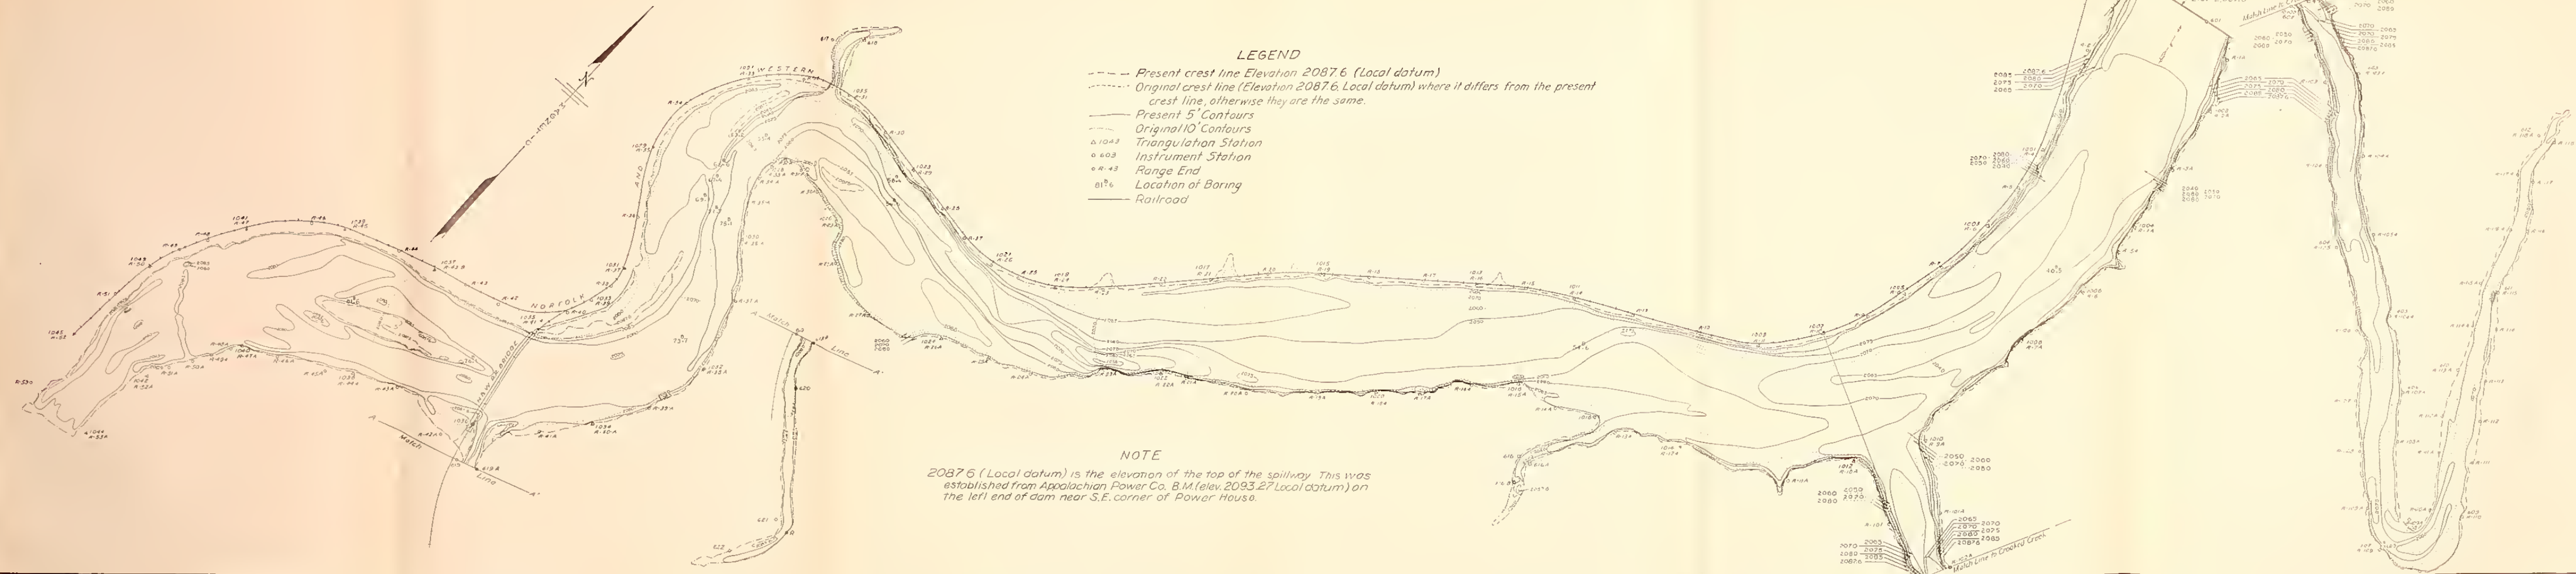
BYLLESBY RESERVOIR  
NEW RIVER  
BYLLESBY, VIRGINIA  
SEDIMENTATION SURVEY

SCALE: 1" = 400'  
DATE OF SURVEY = APR.23 TO MAY 19, 1936  
DIVISION OF RESEARCH  
SEDIMENTATION & HYDRAULIC STUDIES

Byllesby Reservoir. - Byllesby Reservoir was surveyed by the contour method of volume determination, since the thickness of silt in most of the reservoir was too great for direct measurement with spudding apparatus. This type of survey was made possible by the availability of a blueprint of an original map of the reservoir with a scale of 1 inch to 200 feet, and a contour interval of 10 feet. Due to certain omissions on this original map, the original bottom profile of the river was checked by a series of 15 auger borings through the silt deposits taken along the main channel and the Crooked Creek arm. The present crest level shore line and dam were mapped by stadia from triangulation control, and the basin below crest level was mapped by soundings along parallel ranges (fig. 4).

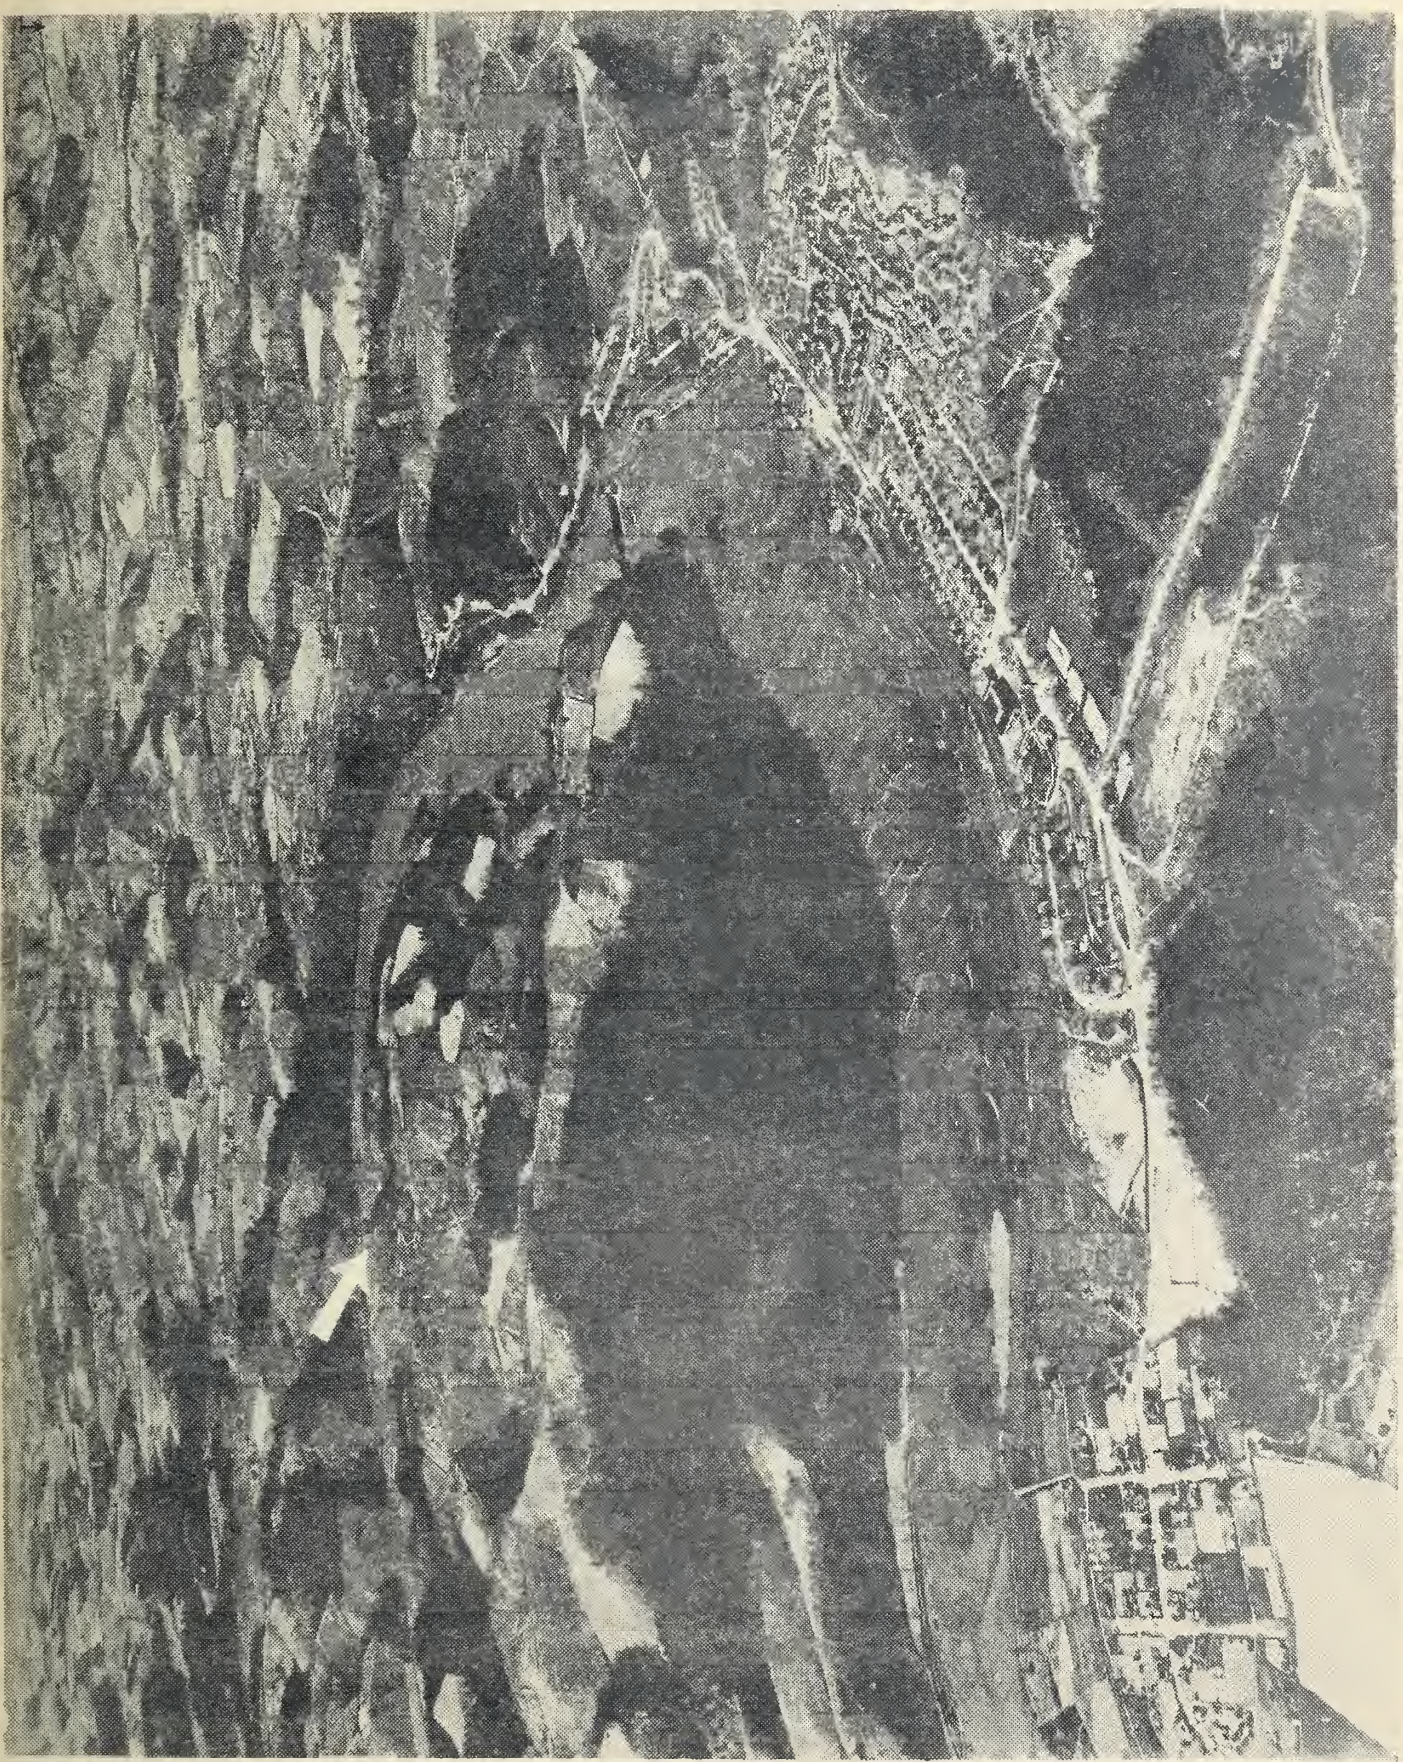
Figure 7. Aerial view of Washington Mills Dam and Reservoir. Arrow indicates head of backwater. Fries, Va., in foreground. (Courtesy of Aerial Surveys of Pittsburgh, Inc.)

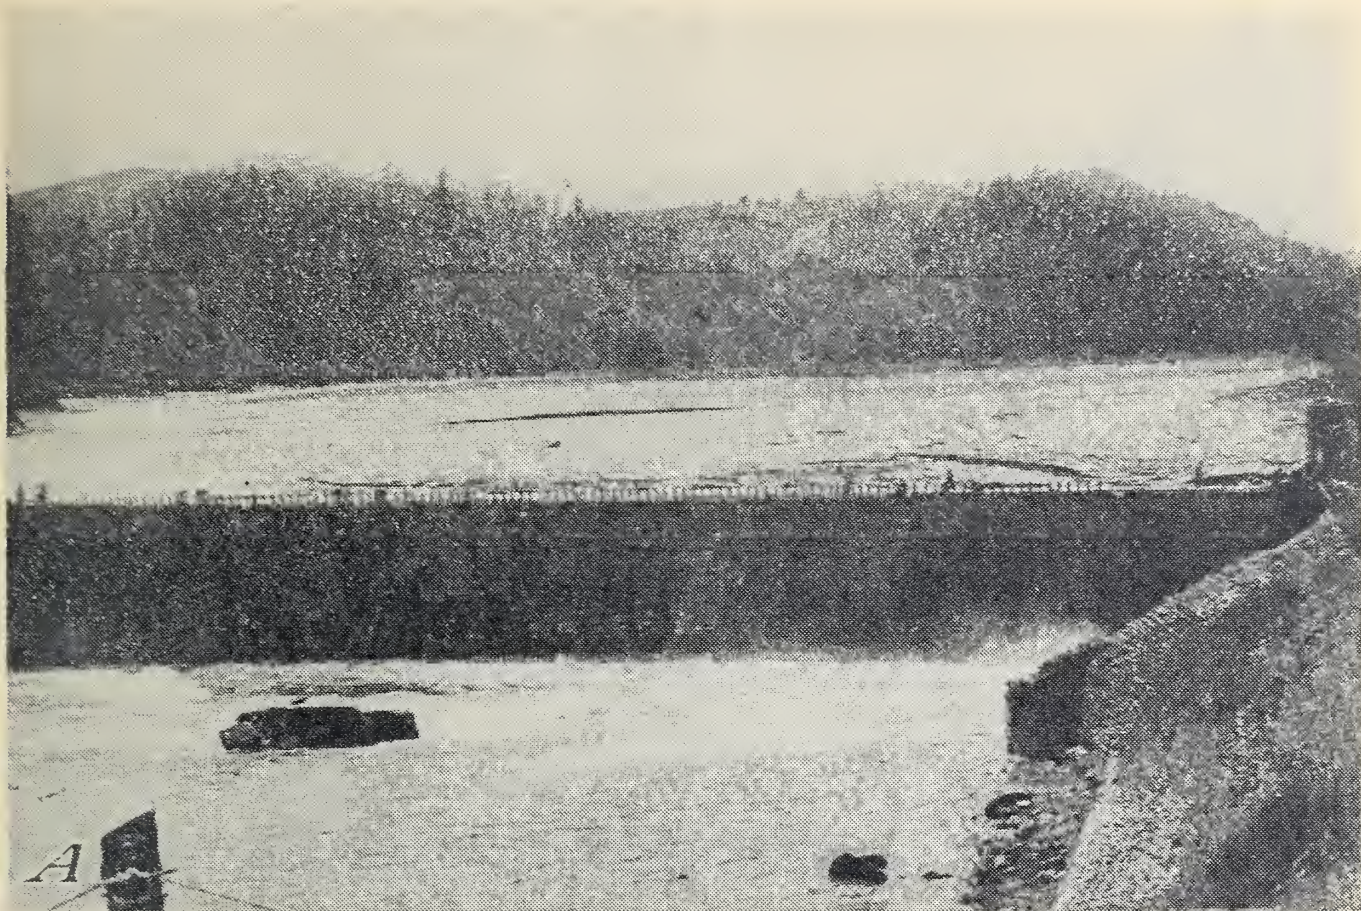
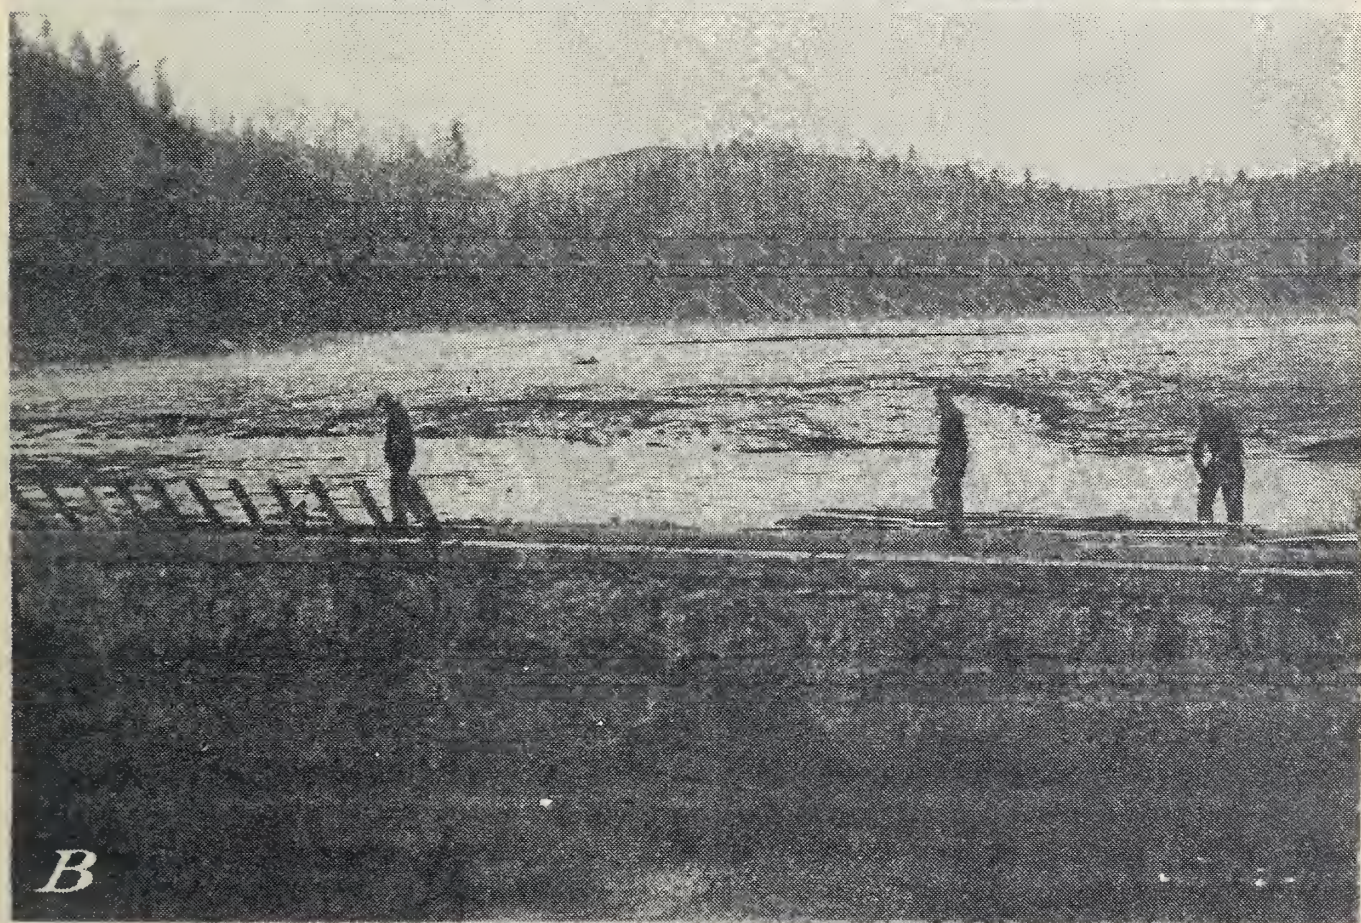
Figure 9.-A. View upstream across Washington Mills Dam during draw-down, showing silt deposits within a few feet of crest level. B. View upstream across Washington Mills Dam, showing silt deposits and channel being cut during draw-down. The current is flowing to the right in the foreground toward the headgates.

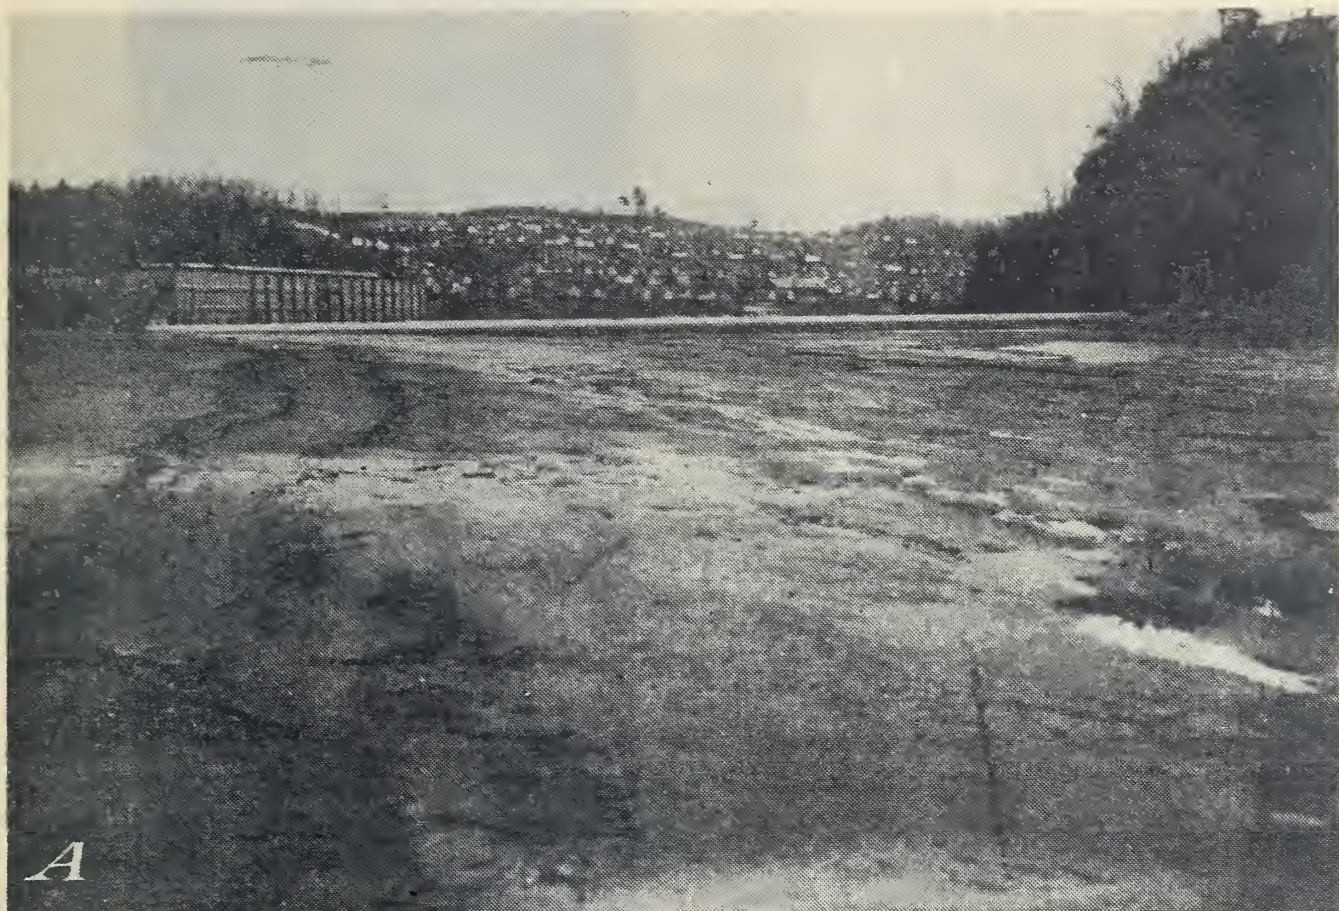
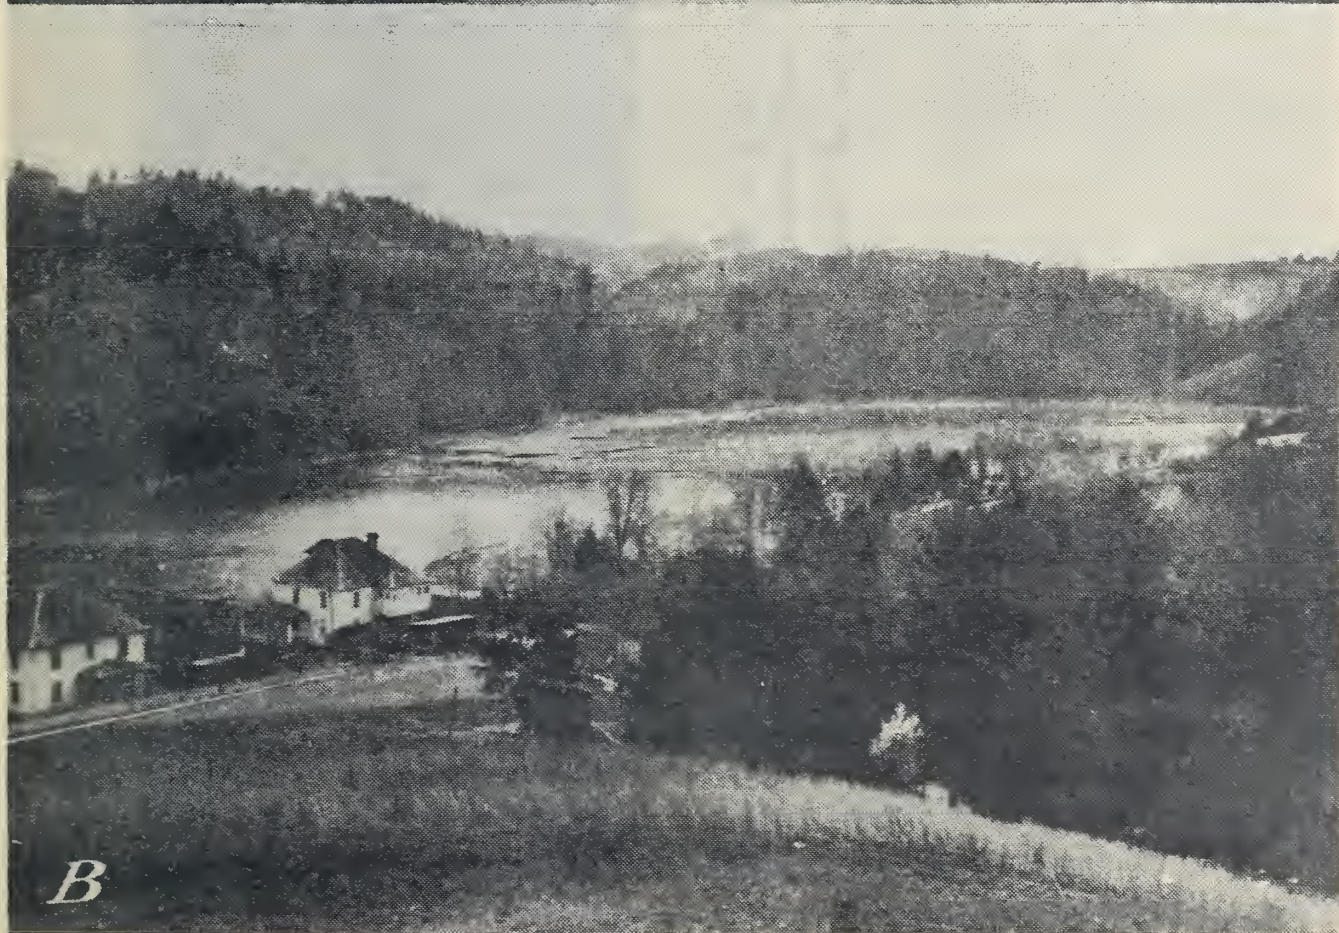
Figure 10.-A. View downstream at Washington Mills during draw-down, showing silt deposits just above the dam. B. View of the lower end of Washington Mills Reservoir, showing embayment filled to crest level with silt deposits.

Another practice followed by the Washington Mills Company is to open the headgates from the canal to the river below the dam, allowing all the stored water as well as normal discharge to drain out rapidly, washing silt with it. On April 18, 1936, 6.76 acre-feet of silt--equal to 1.32 percent of storage capacity before draw-down, or 23 percent of the original capacity--was flushed from the basin by this process. (figs. 2, 3, and 15). Better results are prevented by the fact that the bottom of the 5 headgates are 20 feet or more above the original stream bed, and are all at one end of the dam. Silt is thus scoured from a single narrow channel extending about 2,000 feet above the dam, and to only about one-half the depth of the deposits, leaving the greater part untouched (fig. 10-B).

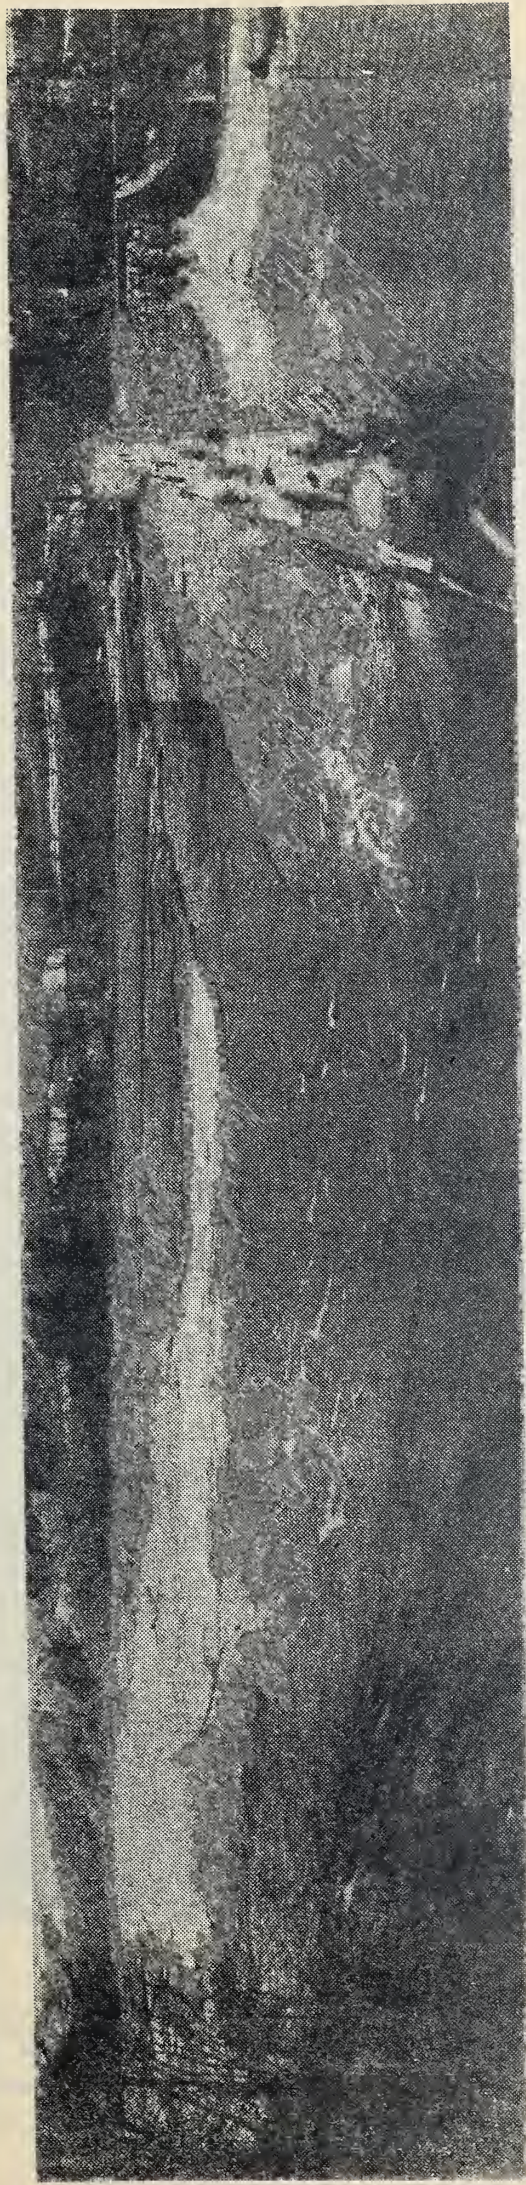
Figure 11. Panorama of Washington Mills Dam and silt deposits, taken while the reservoir was drained for repairs to flashboards.
